JOURNAL OF
Architectural Conservation

Impacts of Fire on Stone-Built Heritage

An Overview

Miguel Gomez-Heras, Stephen McCabe, Bernard J. Smith and Rafael Fort

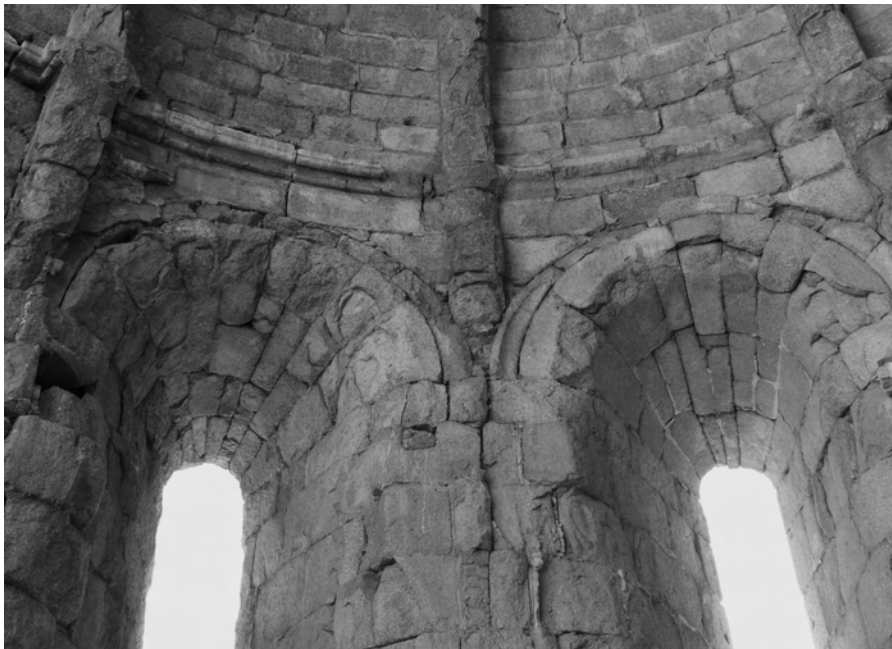
Figure 1 Severely spalled granite as a consequence of an historical fire. The concentrically ‘onion-skin’ structure of the spalling is especially noticeable in the window arches, through which flames may have moved to the exterior of the building.

The cracking of stone at high temperatures, coating by soot and colour change in stones containing iron are the most obvious effects generated by fire (Figures 1 and 2). Possibly because of this, most early research was almost anecdotal in nature, and focused on macroscopic observations of bulk changes to stone caused by fire.³

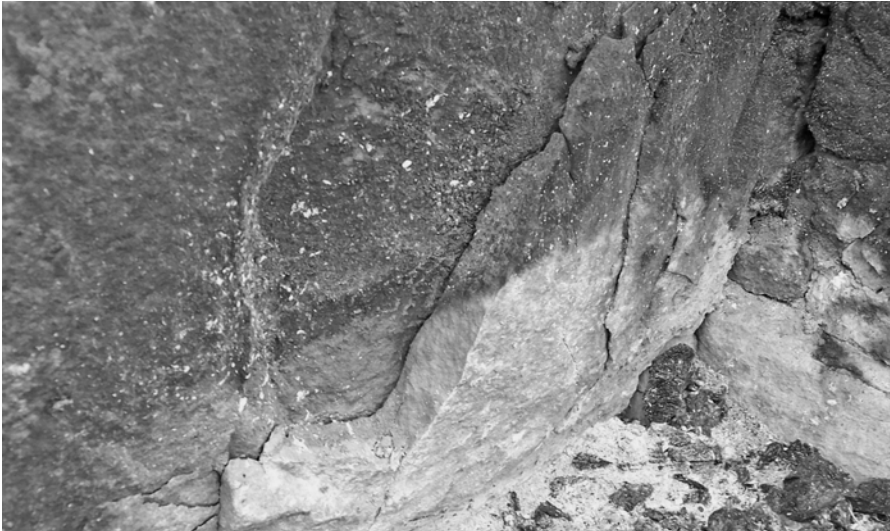
Figure 2 Sandstone after a localized fire at Dungiven Priory, Northern Ireland – note the discolouration (reddening) of stone in the ‘clean’ area where the flames burned, the soot-coated stone above, and the fracturing which caused severe loss of material.

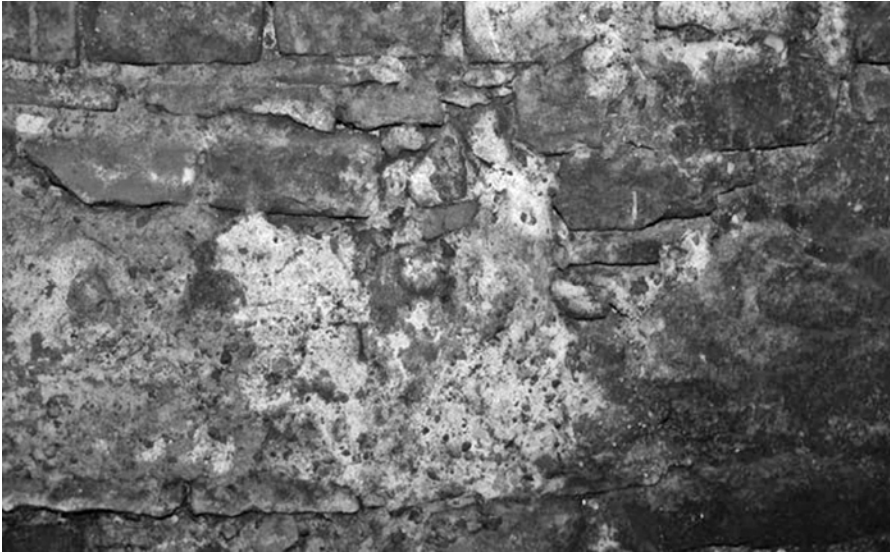
Figure 3 Salt efflorescences related to a soot cover generated by fire (picture courtesy of Mr P. Rohlen)

As well as the effects produced by temperature increase, the combustion residues produced during a fire could feasibly generate effects on, and within, stone that may have long-term consequences. The smoke, oils and fumes can soil surfaces and, in so doing, add further discolouration to that already generated by iron reddening.¹³ Fumes and ashes also introduce new elements to the stone, such as carbon, sulphur, nitrogen and phosphorus and organic compounds, such as oil and waxes, that can coat the stone surface and fill near-surface pores. The combination of these elements with other products from the alteration of the stone may generate salts, such as sulphates, nitrates or phosphates. This may have severe consequences for the future decay of stones (Figure 3).

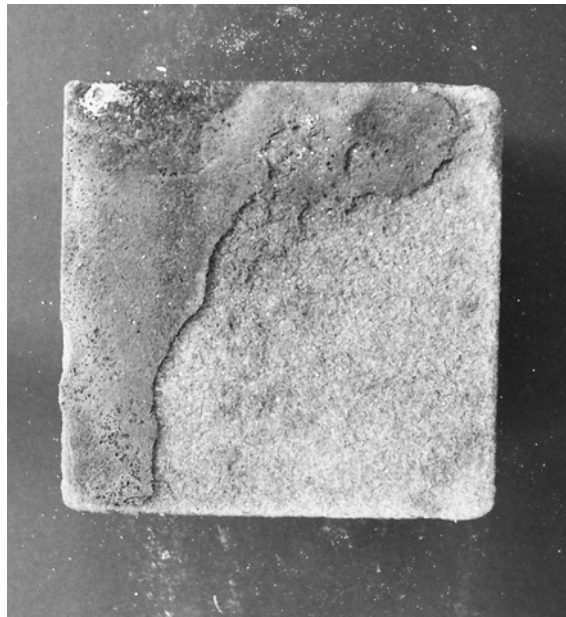
Figure 4 A block of sandstone subjected to real fire and salt weathering simulations in the laboratory. The less permeable soot crust has detached as a result of salts concentrating and crystallizing behind it, exposing more permeable, fire-damaged, sandstone beneath. The exposed stone exhibits rapid granular disaggregation as a result of exploitation by salt weathering.

The behaviour of a natural stone façade in a ‘post-fire’ environment will depend on whether the fire was experienced recently or in the distant past. If a fire has occurred recently then blackening of stone is the most blatant ‘memory’ effect. While studies simulating fire with furnace-heating have rightly highlighted the reddening of sandstone,¹⁴ the fire experiment reported by McCabe et al.¹⁵ makes it clear that the blackening of stone from soot is an important by-product of fire, and the most obvious immediate surface effect. This soot cover brings with it the likelihood of reduced permeability and hydrophobic tendencies, influencing subsequent exploitative decay processes that rely on moisture ingress. In the short term, this hydrophobicity may be associated with the severe dehydration of the stone surface, but in the longer term it may be influenced by the deposition and coating by, for example, waxes and other hydrocarbons. The patchy nature of any surface soot cover might also promote other surface/subsurface heterogeneities and can result in detachment of the artificial surface crust in the form of flaking, when salts concentrate and crystallize behind the soot (Figure 4).
